Docket No. 217 – Development and Management Plan Inspection

Date: December 30, 2005

Location: 115 kV Underground Route

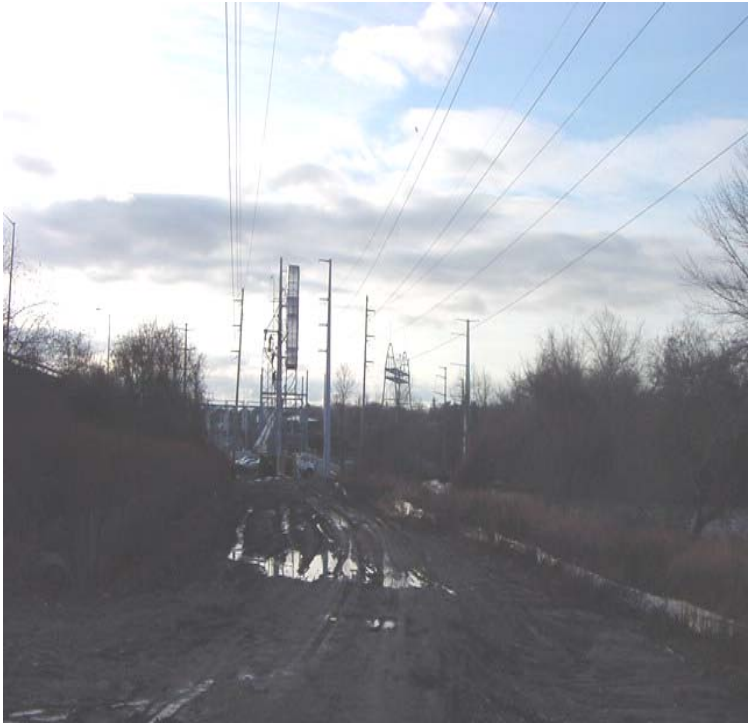
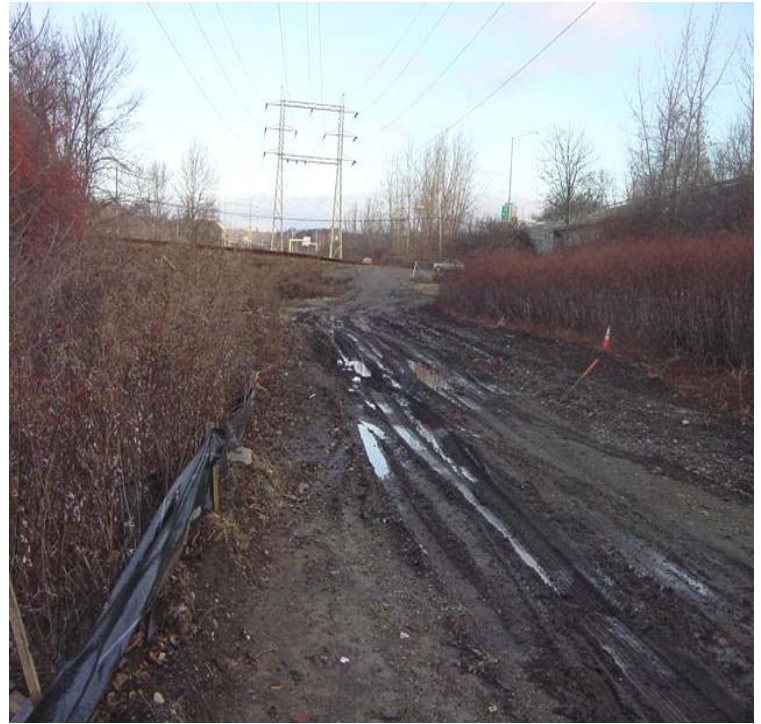
115kV (ROW): Both photos show views of the ROW which was very muddy at this time. Photo on the left is looking towards the scaffolding and shroud work on the structure. Silt fence repair may be needed near the work area. 12/30/05

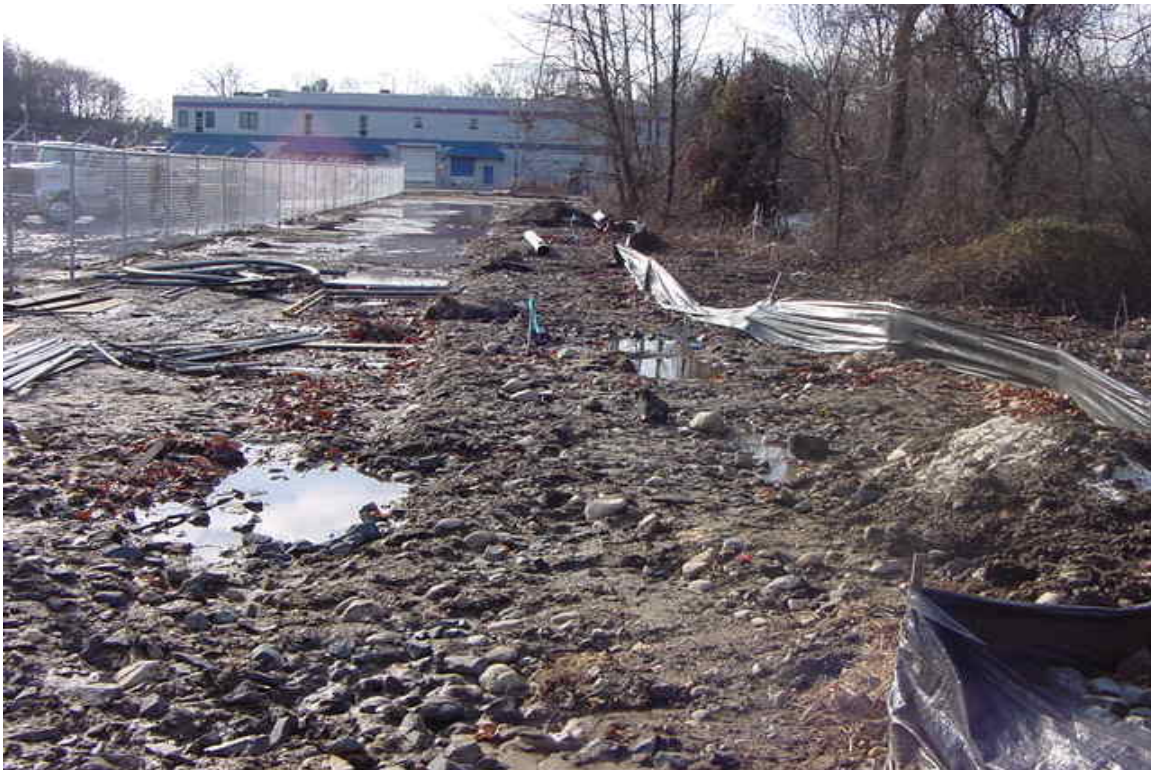
Areas of Inspection	Observation	Recommended Action
Rt. 7, Norwalk	-Erosion controls were pushed over as a result of the snow plowing at Norwalk Junction- apparently for 115kV related work on the structure. This has pushed sediment laden snow towards the river beyond the silt fence. 12/14-12/30/05	- The 115kV contractors should repair the fence and pull back the snow piles if it is determined to be their responsibility. This should be worked out among the contractors. 12/22-12/30/05
Soils	-Clean process remains in one pile at the Putnam Park storage area. Clean soil was spread at the Rt. 107 and Sunset Hill storage areas. 12/22-12/30/05	- All soils appear to be handled appropriately. 12/22-12/30/05
Adjacent Wetlands and Waterways	-The stream near Sara's Way off Rt. 58 remains clear and banks are free from erosion. 12/30/05 - A small stream crossing near Putnam Park at a vault also remains clear at this time. 11/23-12/30/05 -Some soil was accidentally pushed into the wet swale adjacent to the storage yard on Sunset Hill Rd. 12/22-12/30/05	- None at this time. Continue to monitor for final vegetative stabilization. 12/30/05 - Monitor as bare soil remains around the stream. A few haybales could be installed. 12/30/05 - Shovel back soil if feasible and install erosion controls until the next growing season. 12/22-12/30/05

115kV (Norwalk Junction): Photo shows a view of the remaining snow/sediment pile from project related plowing at Norwalk Junction. Responsibility for silt fence repair needs to be determined ASAP. 12/30/05

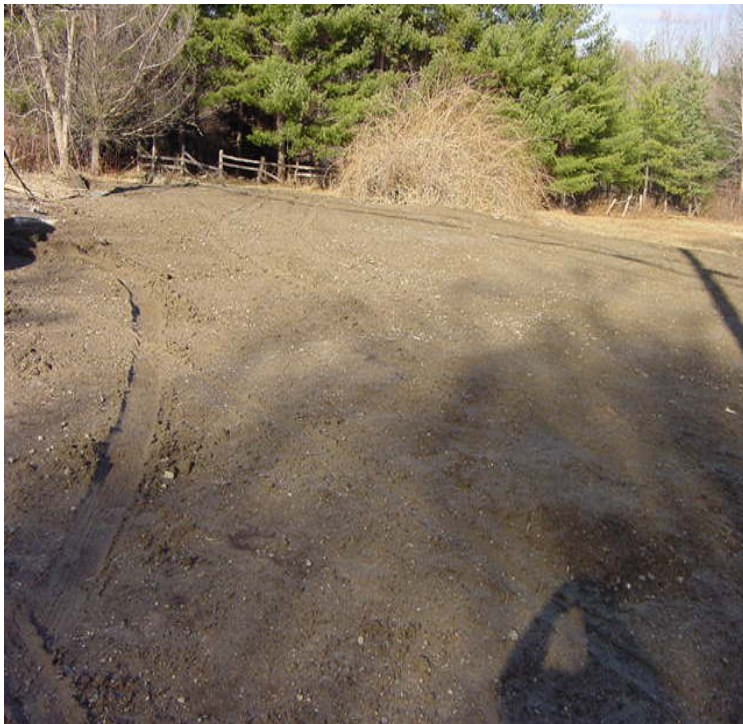
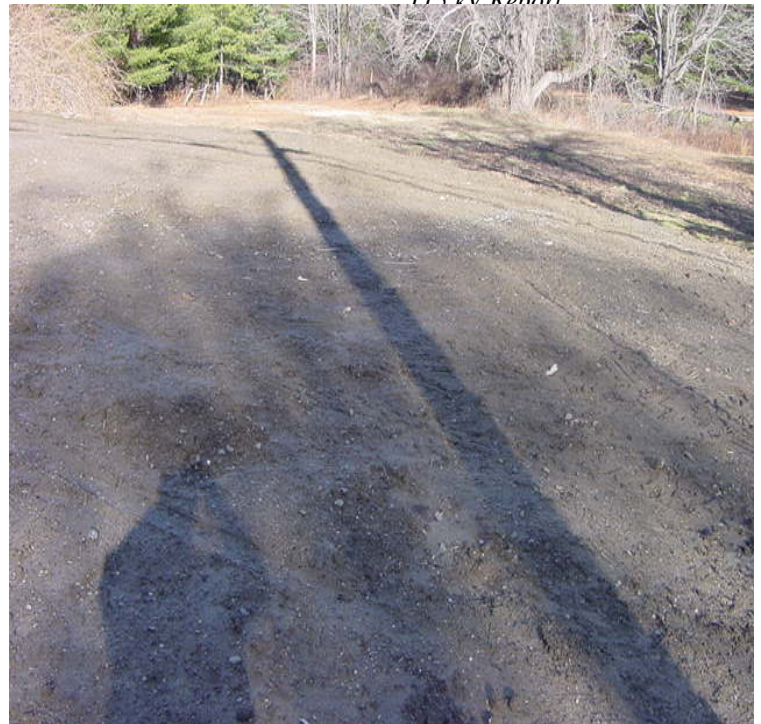
115kV (Rt. 107 storage yard). Both photos show views of the storage area near the Rt. 107 90 degree turn which does not show signs of erosion since being placed with topsoil. Due to muddy conditions and potential for run-off we recommend leaving toed-in silt fence here. 12/30/05

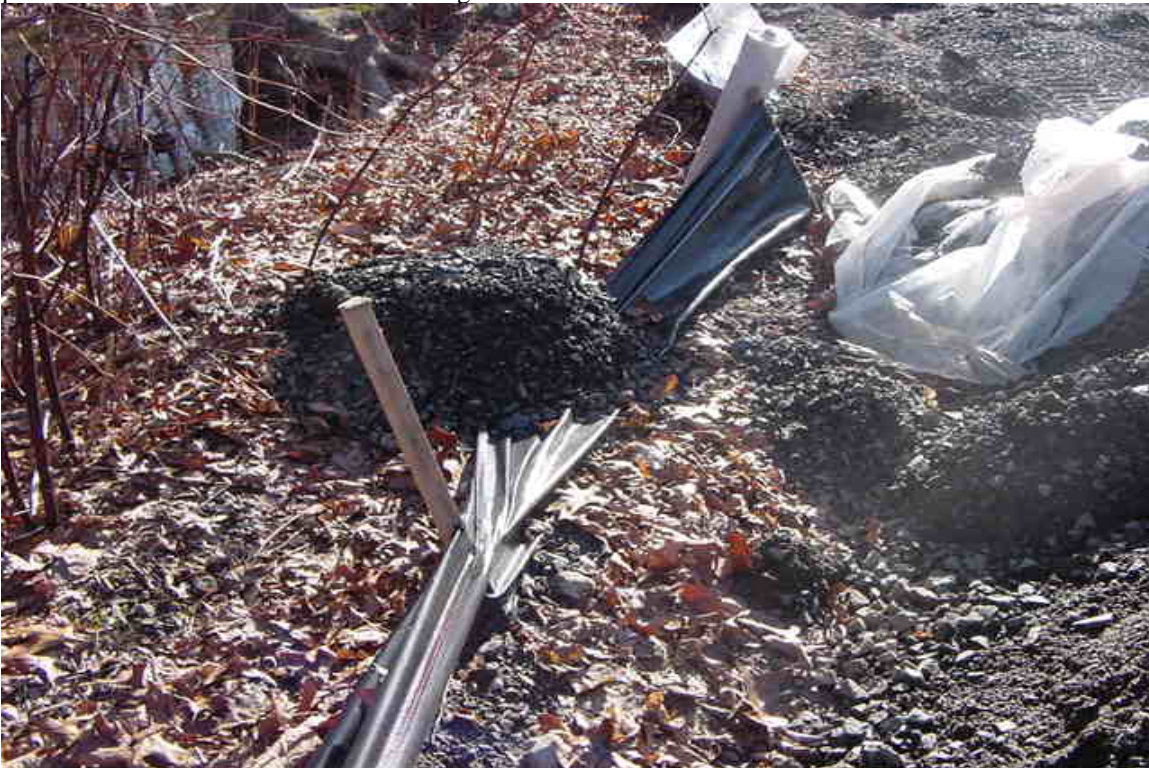
Staging, Storage, and Parking Areas	- At the storage area off Rt. 58 near Putnam Park controls were pushed over by sediment laden snow plow piles in some locations. 12/14-12/30/05 - The Sunset Hill Rd. and Rt. 107 storage yards have been graded and placed with topsoil and are no longer in use. However, the amount of disturbed soil left behind warrants additional attention. 12/22-12/30/05	-Snow needs to be pulled back and erosion controls repaired. Retain the silt fence here due to the proximity of the pond. 12/14-12/30/05 - Since disturbed soil remains and there is no chance of re-vegetation until the growing season, we recommend haybales or other erosion controls. The areas were not mulched prior to pulling the silt fence. 12/30/05
State species of concern, threatened and endangered species	- No species of concern are located in the areas of construction.	- N/A

115kV (Putnam Park Storage Area) The photo shows a view the silt fence pushed own as a result of snow plowing several weeks ago. Chunks of process/sediment were on the wetland side as a result. These should be pulled back and the silt fence restored until the growing season. 12/30/05

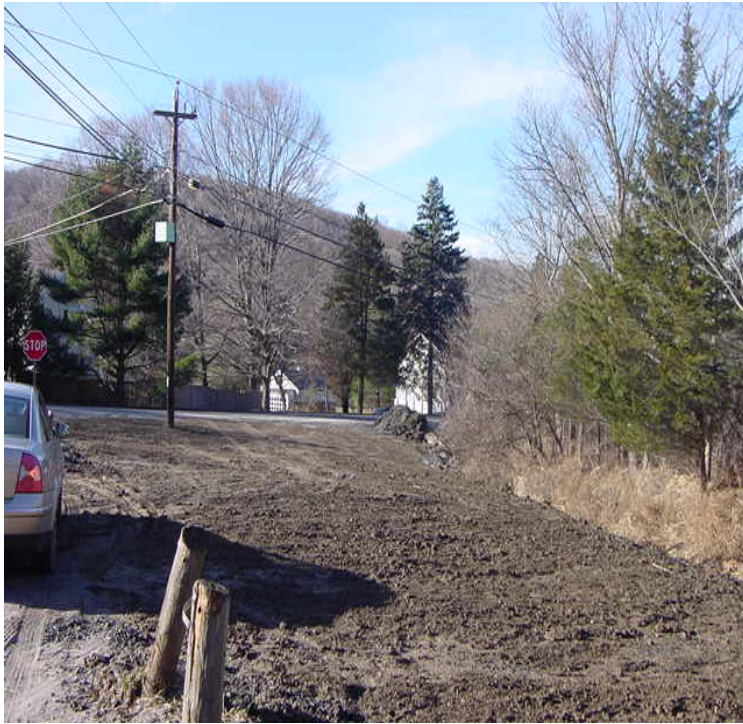
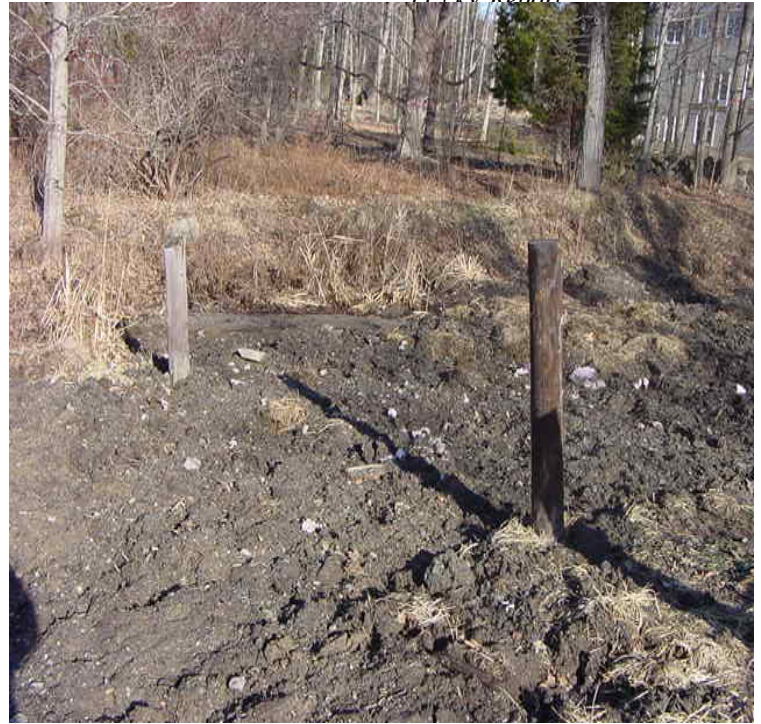
115kV: (Sunset Hill Rd. Storage Area) Both photos show views of the Sunset Storage areas. The site was in fairly good shape but some erosion was noted. Due to muddy conditions and potential for run-off we recommend leaving toed-in silt fence or haybales until growing season. 12/30/05

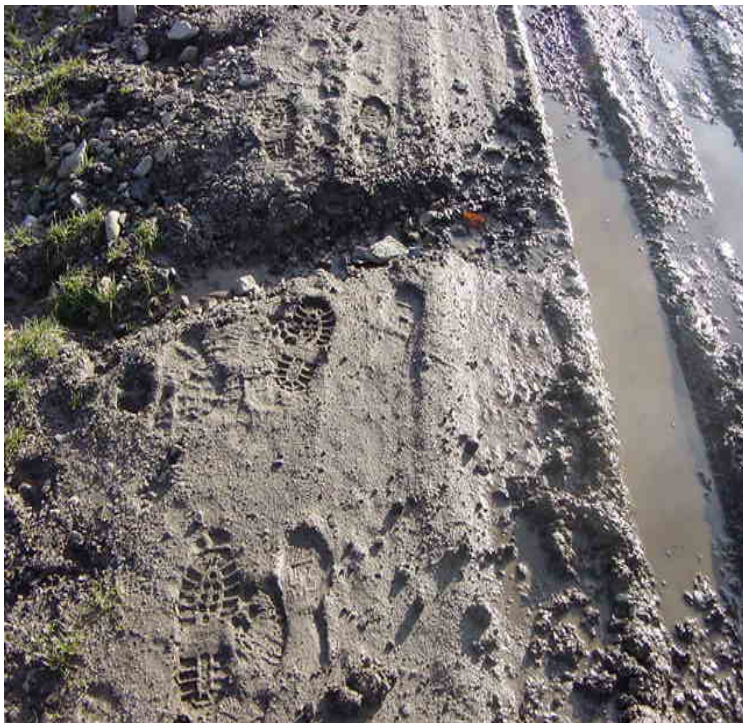
115kV: (Bethel Ed. Park) Photo on the left shows the small area along the ROW that continues to wash-out and gully. Photo on the right shows some snow/sediment over the silt fence along the ROW. 12/30/05
